April 2013

## Alligatoring of the Membrane

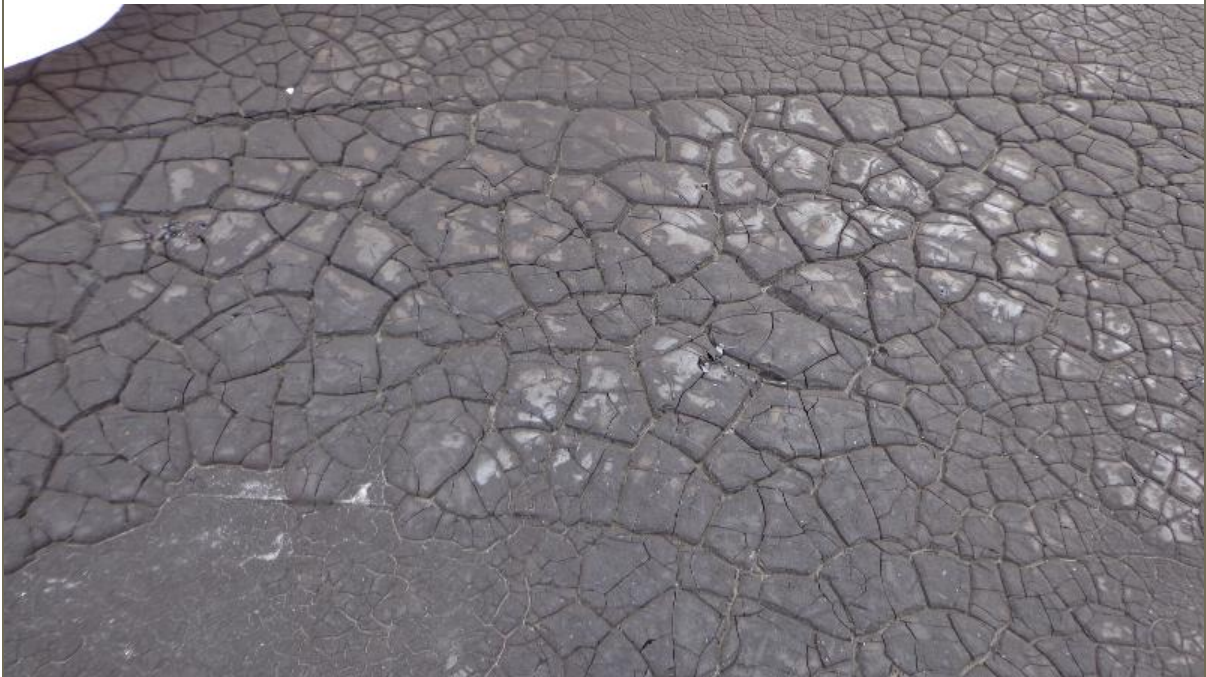
Alligatoring is the term used to describe the roof condition pictured above, mainly because it looks very similar to an alligator's hide. Appearing on smooth-surfaced built-up membrane roofs, the shrinking and cracking of the surface bitumen is often due to ultraviolet radiation and the subsequent embrittlement of the membrane. Alligatoring also occurs on some coatings. The pattern is made up of cracks in the surface. (If the cracks are very small, the condition is referred to as checking.) The cracks sometimes extend through

the surface bitumen or coating.

The cracks intensify, allowing moisture to enter the roofing system. The moisture can travel throughout a flat roof, which can cause leaks that are located far away from the actual source of entry. Water, as we know, expands and contracts as it freezes and thaws. As this occurs underneath the roofing surface, the cracks will grow in size. As the surface fails, the underlying felts become exposed and brittle. Roofing system failure follows. Water damage is accelerated in areas which also contain ponding water.
